**ASBESTOS SURVEY RESULTS
1975 JEFFERSONVILLE ROAD
MACON, GEORGIA
GEC JOB # 160190.240**

**ISSUE DATE:
May 18, 2016**

**SUBJECT: Asbestos Survey Results
1975 Jeffersonville Road
Macon, Georgia
GEC JOB # 160190.240**

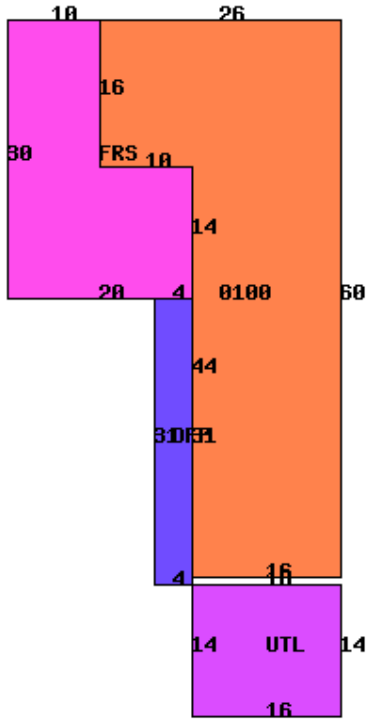
Color	Area Type Description	Square Feet
	1 STORY	1120
	Frame Storage	440
	Utility Room	224
	Open Frame Porch	124
